WHARF STREET RETAINING WALL CONDITION ASSESSMENT REPORT

Wharf Street, Victoria, BC.

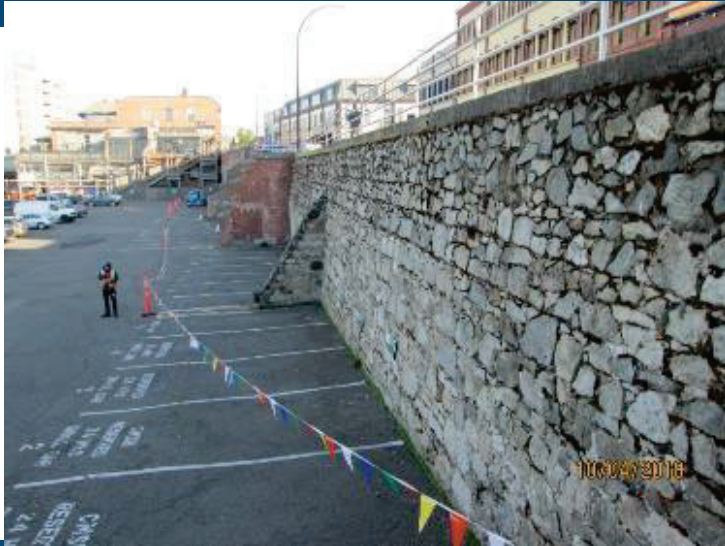
PREPARED FOR:
MR. DAVID LUZZI
CITY OF VICTORIA
#1 CENTENNIAL SQUARE
VICTORIA BC
V8W 1PG

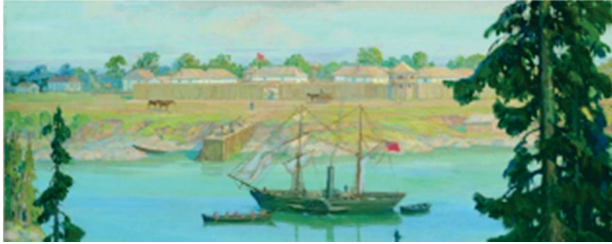
PHOTO 6: 1846 Fort Victoria viewed from the Songhees Lands. The original wooden wharf can be seen

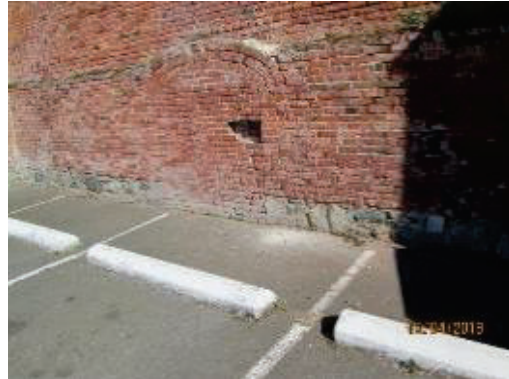
PHOTO 18: Post demolition, the access to an additional basement located below the sidewalk can be clearly seen. As with the HBC Warehouse there was likely a sub basement area. Photo is circa 1971.

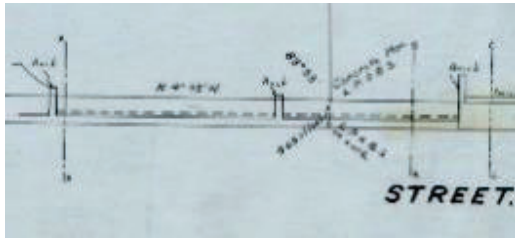
PHOTO 20: An extract from the survey drawing showing the stone retaining wall

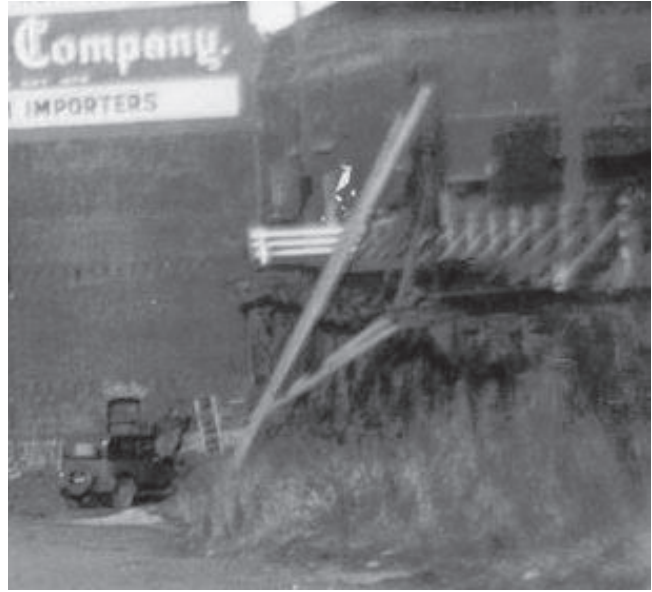
PHOTO 25: An enlargement of a section of PHOTO 17 appears to indicate a trestle type structure to the west of the stone retaining wall.

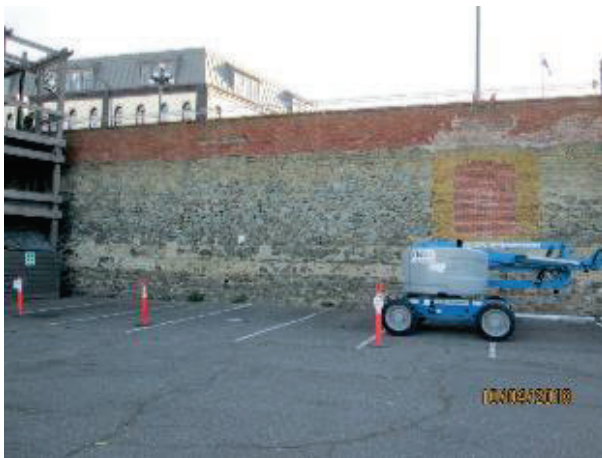
PHOTO 26: Current (2018) overview of northerly section of wall. Some poorly executed re-pointing of the upper section of brick work is evident.

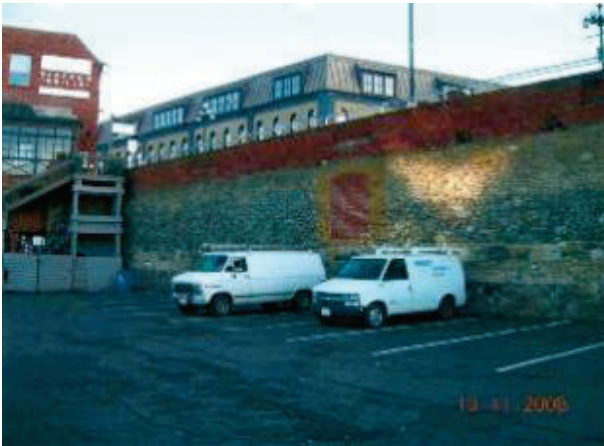
PHOTO 28: Dated 13 November 2008, clearly shows the condition of the upper brick section prior to the repointing work and filling of the beam pockets at the northerly end of the wall.

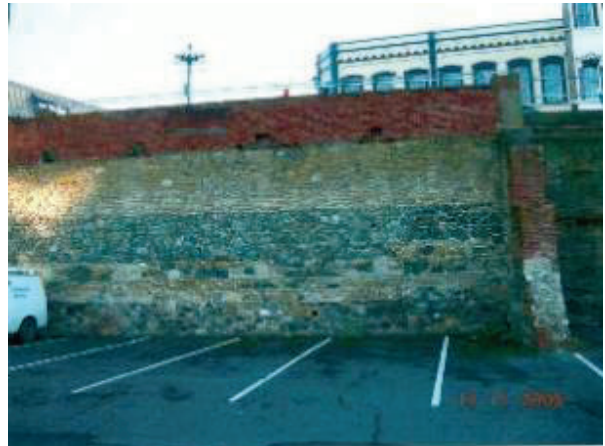
PHOTO 29: Dated 13 November 2008, shows more clearly the beam pockets at the upper brick section. It is also a useful reference for the condition of the buttress, before repairs were completed in 2013.

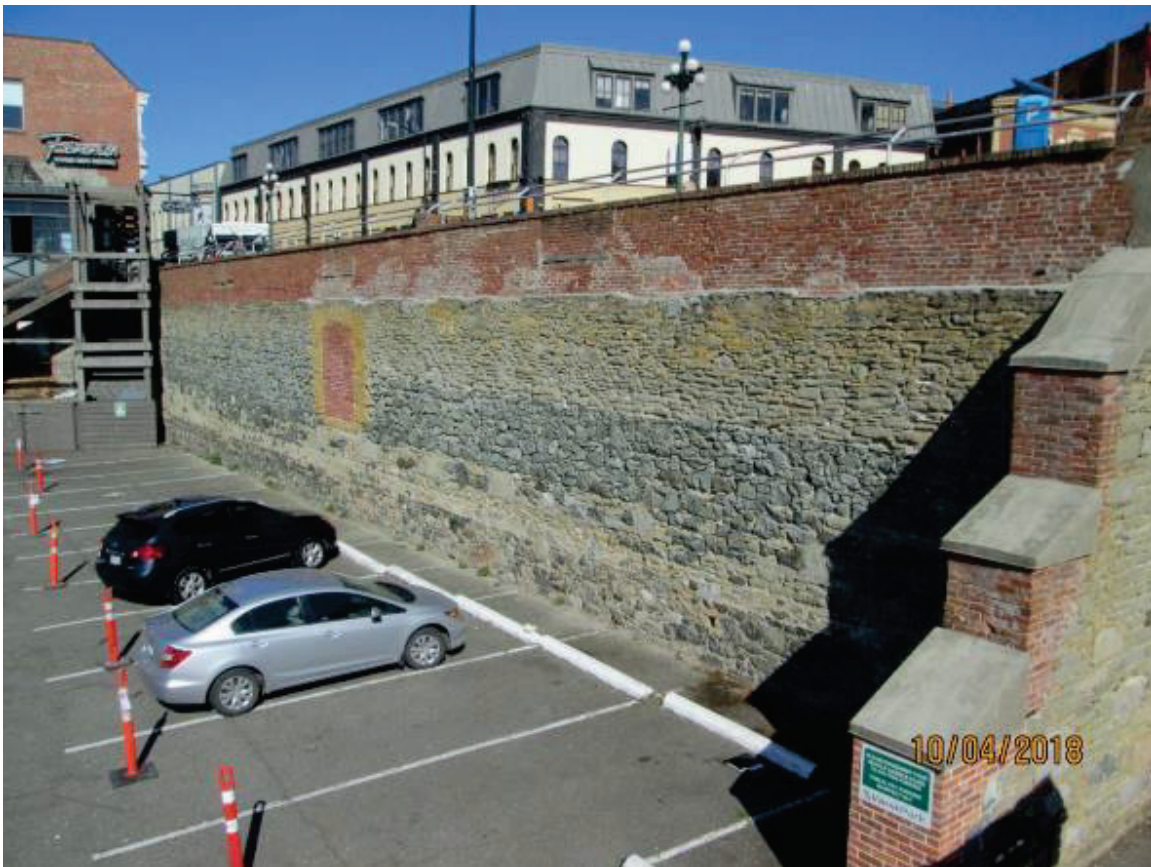
PHOTO 30: A general view of SECTION 1 showing the different construction materials.

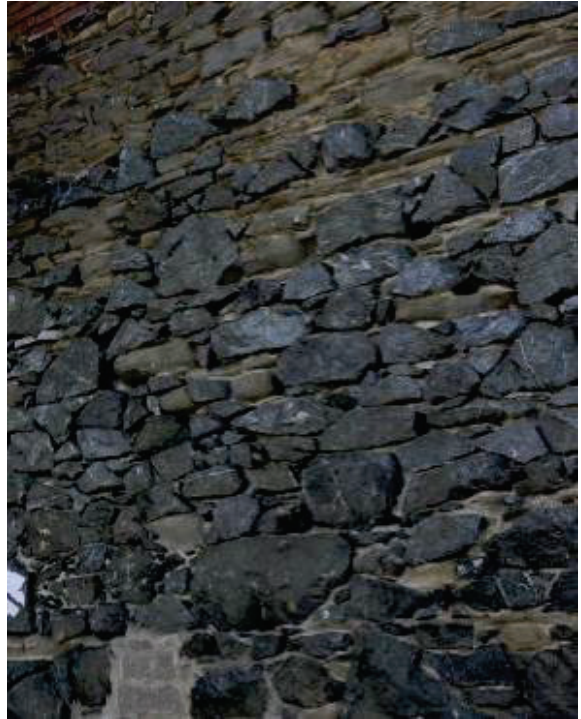
PHOTO 33: 2.0m – 3.9 m Granite band

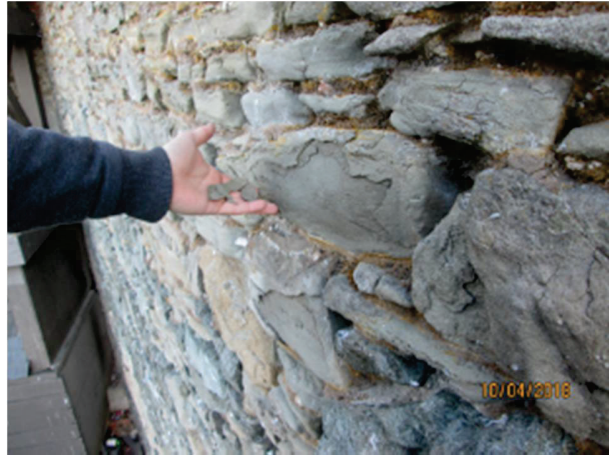
PHOTO 36: Exfoliation of the Sandstone surface is clearly evident

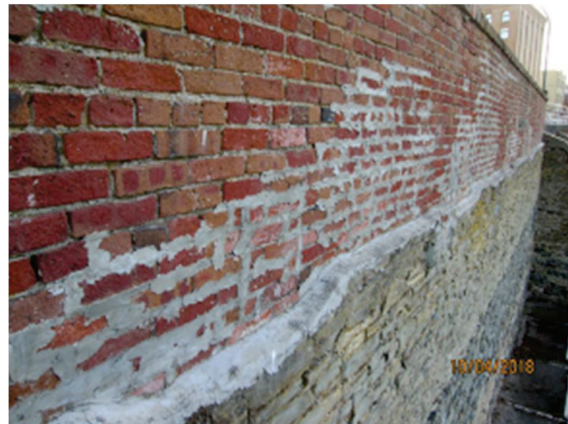
PHOTOS 37 & 38: Poorly executed mortar re-pointing.

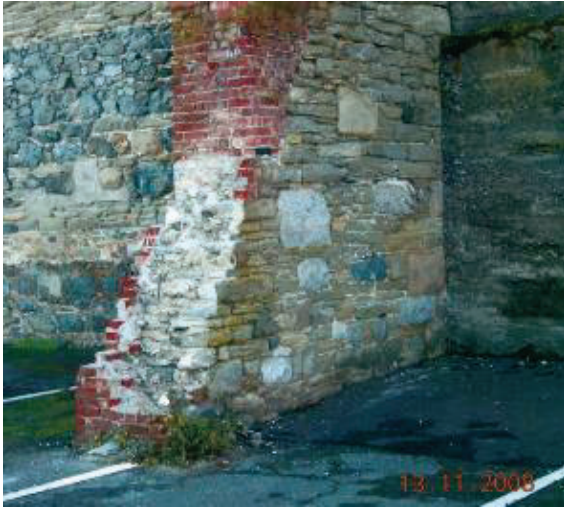
PHOTO 39: Photo taken in 2008 showing degraded condition of the lower portion of the remains of the HBC warehouse gable end wall.

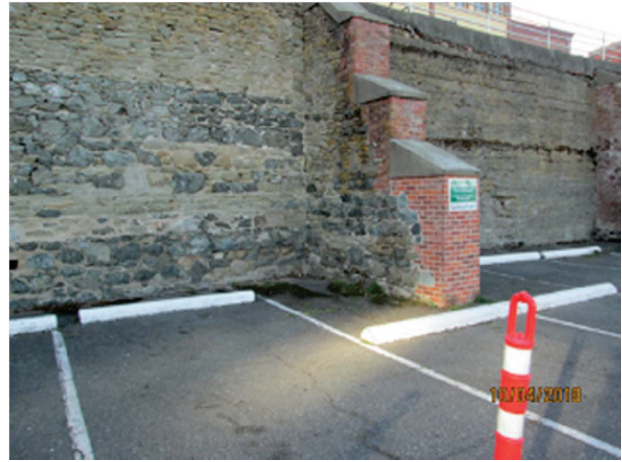
PHOTO 40: Current condition of the wall. Repaired using a mixture of recycled and modern clay bricks.

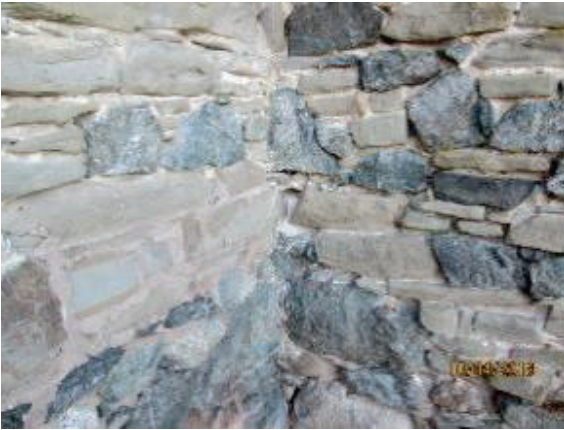
PHOTO 41: Close up of the inside corner of the buttress.

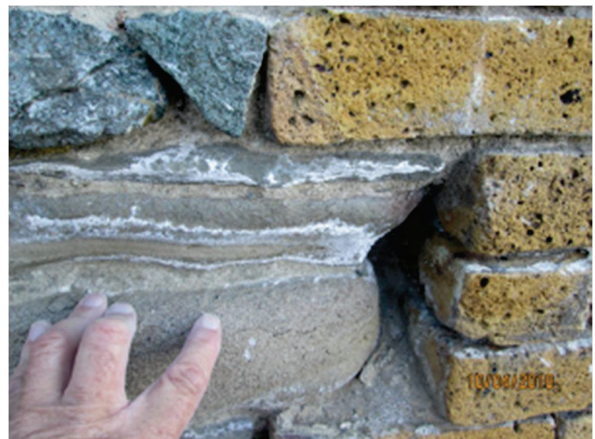
PHOTO 46: Sandstone and clay brick interface. Barnacles were observed on the faces of the sand stone indicating that the material was collected from a shoreline rather than quarried.

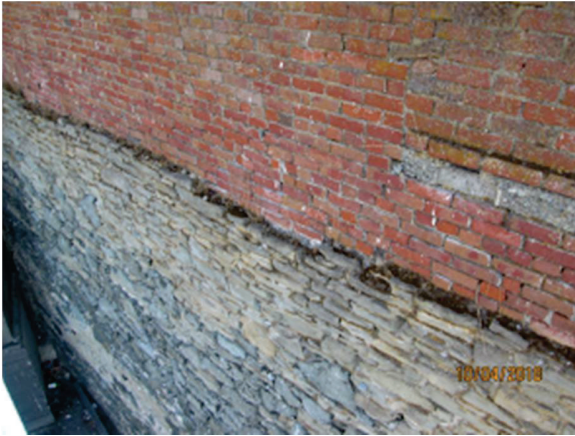
PHOTO 47: Transition from sandstone masonry to clay brick masonry. There is clear evidence of three cast in place concrete door sills.

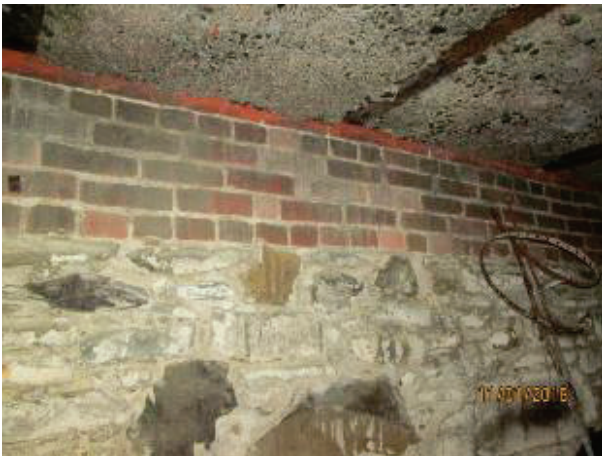
PHOTO 53: The HBC warehouse wall. Mortar jointing has not been subjected to prolonged weathering and was found to be in good condition.

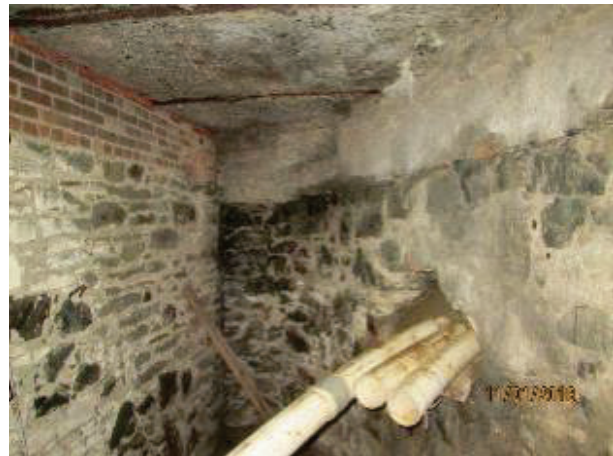
PHOTO 54: The northerly intersection between the stone retaining wall and the exterior wall of the old warehouse.

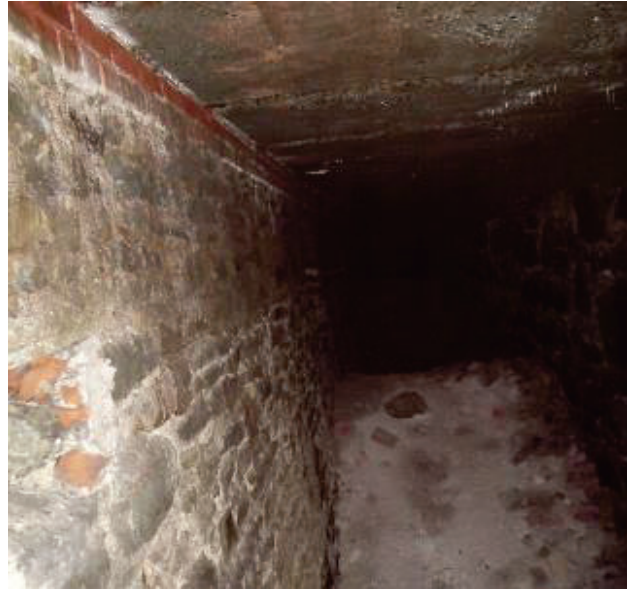
PHOTO 60: Taken during repairs to the exterior buttress, this photo confirms that the chamber extends south of the concrete vault.

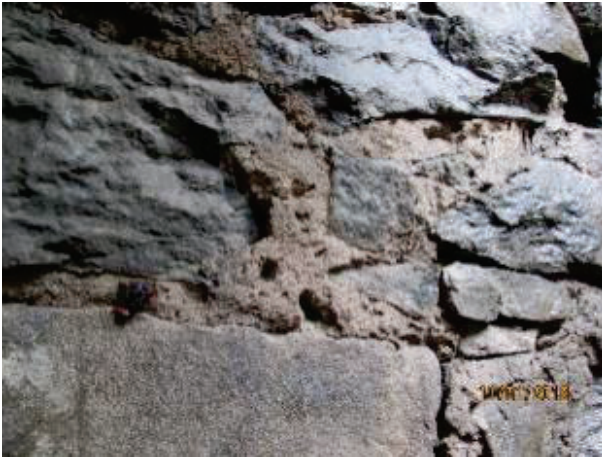
PHOTO 61: A close up of the easterly side stone retaining wall. The mortar joints appear to be in good unweathered condition.

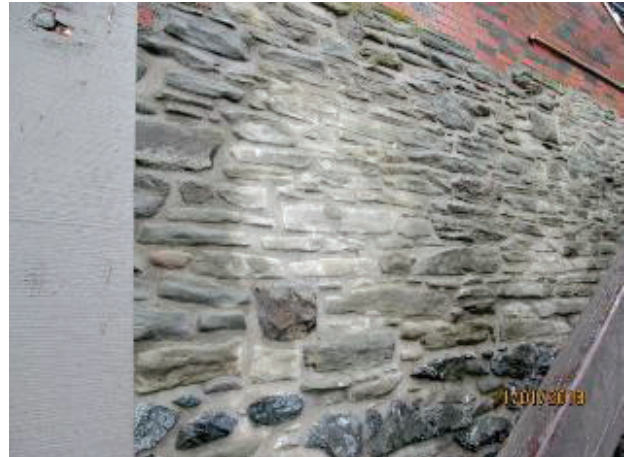
PHOTO 62: Sections of the northerly gable end of the warehouse are preserved. The original mortar has been repointed using a "heritage mortar mix" and is a good example of what the exposed west wall would look like when restored.

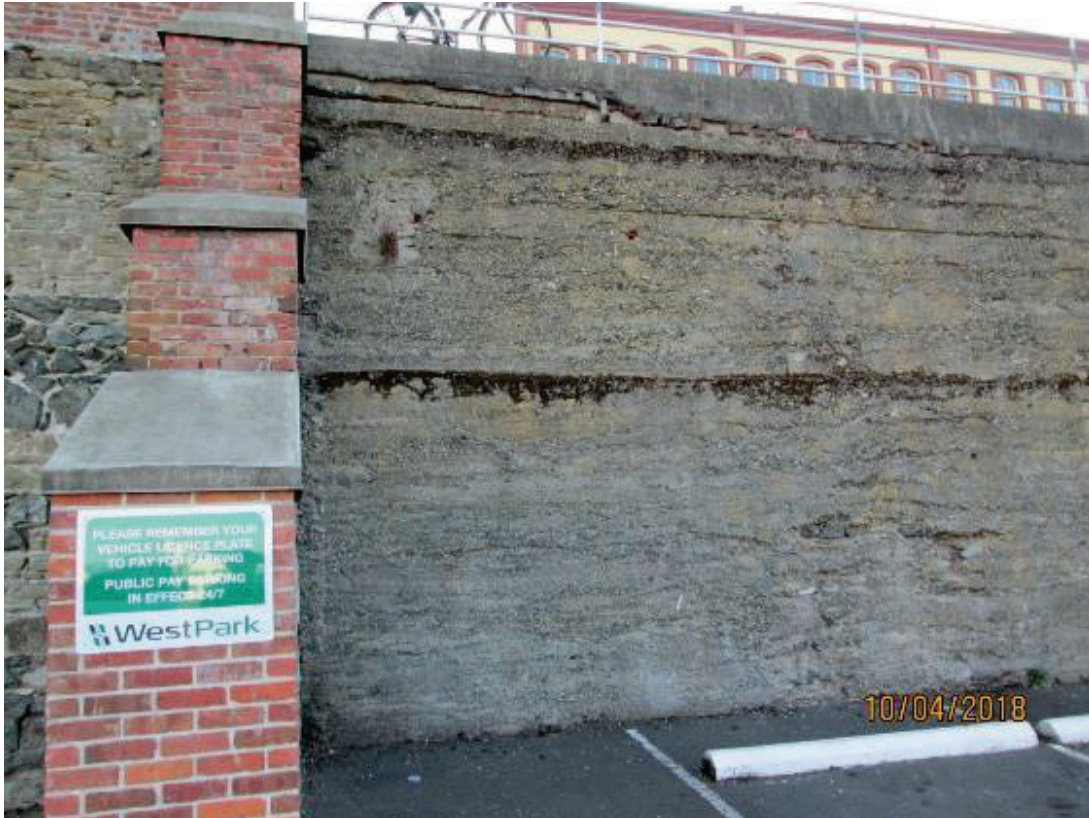
PHOTO 63: The cast in place concrete wall shows a stratification typical of concrete placement technique, common place in the early 20th century.

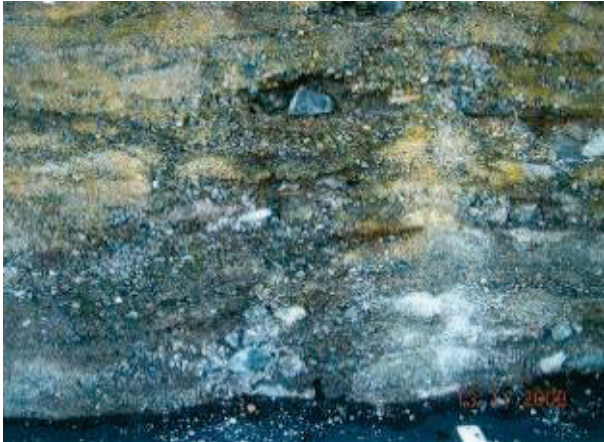
PHOTO 64: Taken in 2008, this photo forms a good base line for our assessment of the current condition of the wall.

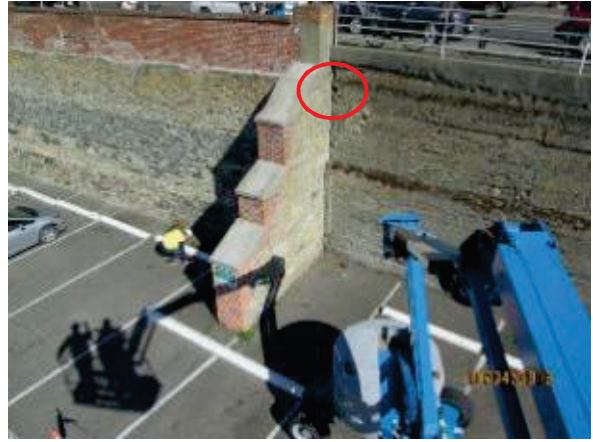
PHOTO 65: A general overview of the section 2 wall and the northerly buttress, repaired in 2013. Highlighted is the small aperture where the void behind section 1 was observed.

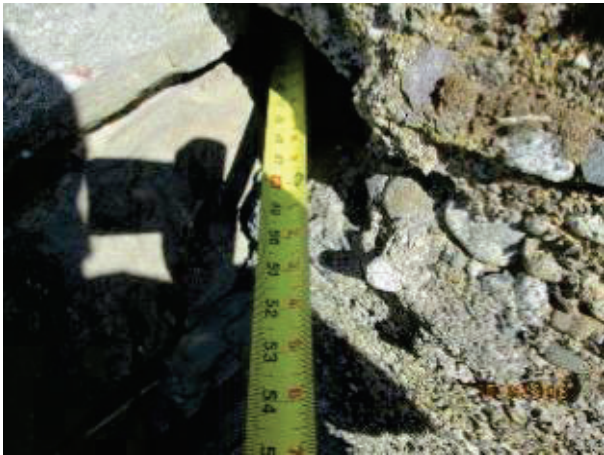
PHOTO 66: The aperture through which PHOTO 60 was taken by personnel from Innovative Structural Preservation in 2013. The image was published in the Times Colonist Newspaper.

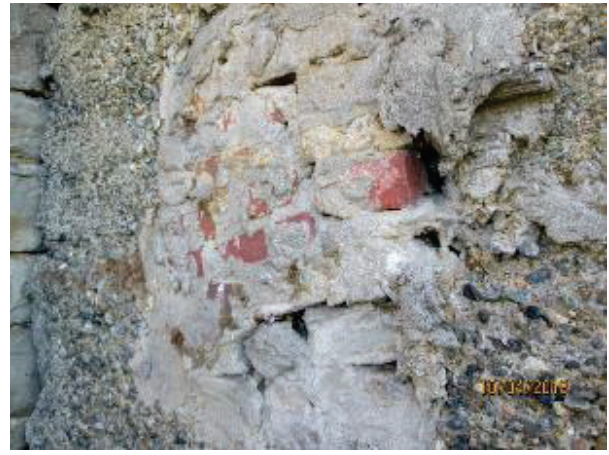
PHOTO 67: poorly executed patch repair. This repair predates the 2008 photos and appears as a lighter patch in PHOTO 18, taken in the early 1970's

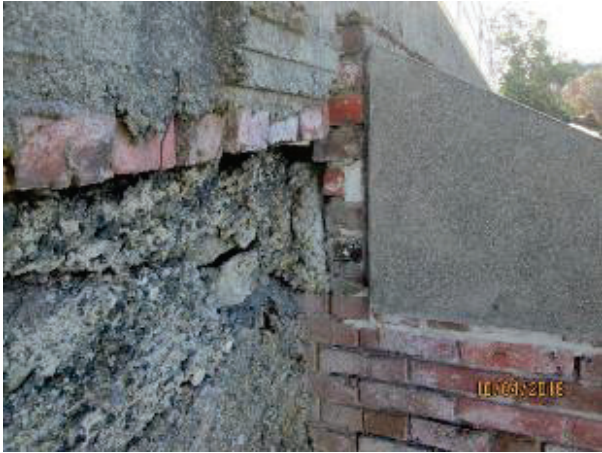
PHOTO 68: Poor condition of the upper and presumably later layers of concrete that form the current sidewalk curb.

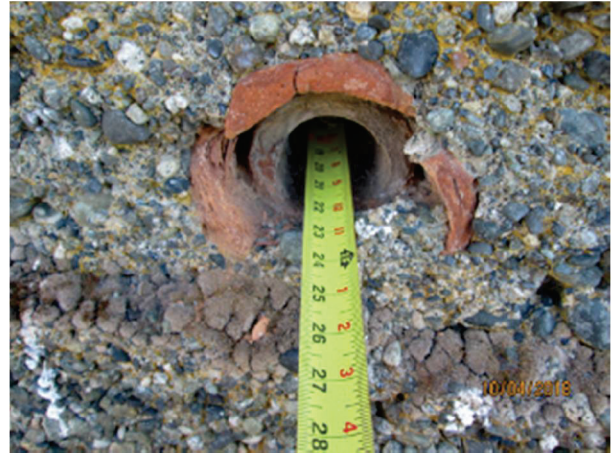
PHOTO 69: Clay drain tile insert.

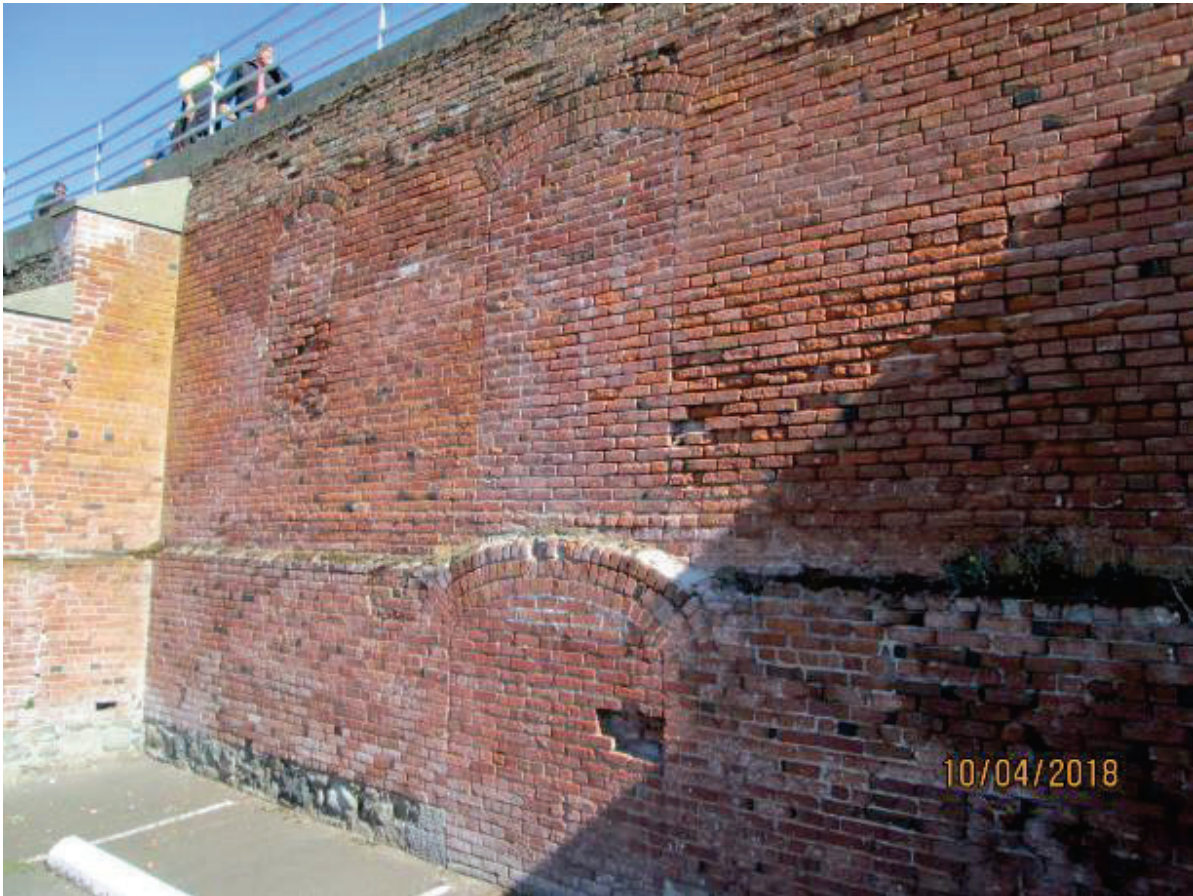
PHOTO 70: General view of the clay brick wall.

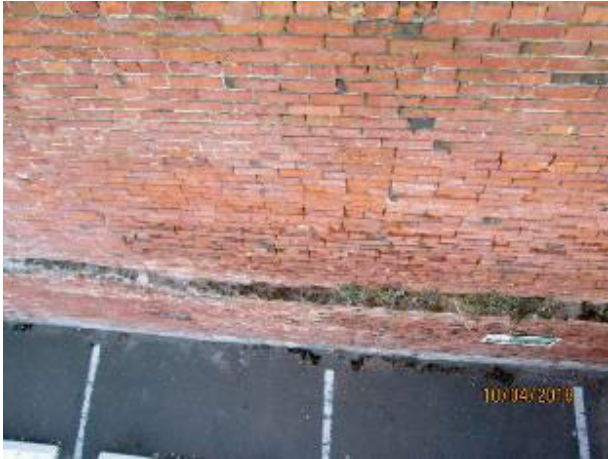
PHOTO 73: An overhead view clearly reveals the mortar loss at the joints and degradation of the exposed brick surfaces.

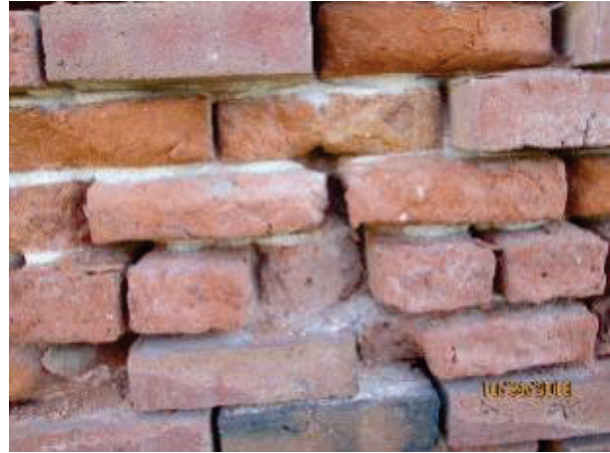
PHOTO 74: Sample area showing different rates of degradation due to variations in the density of the clay brick. Typically, the bricklayers would select the lower fired and duller sounding bricks for the interior surfaces during construction.

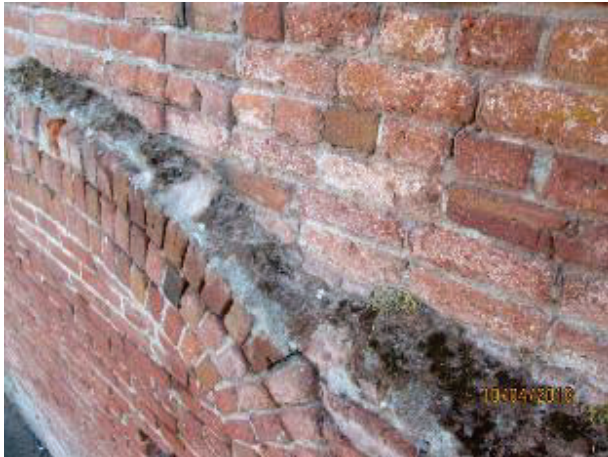
PHOTO 75: The original mortar droppings are clearly visible on this set back ledge. Organic material deposits and growth further act to retain water in high wind and rain events.

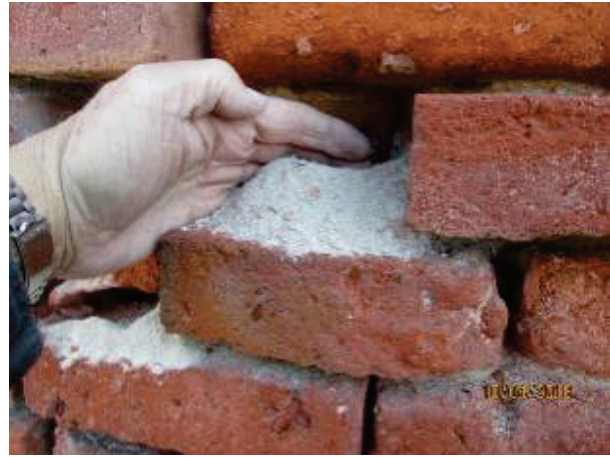
PHOTO 76: The friable nature of the decayed mortar, simply demonstrated. The burnt lime that provides the material stability has been lost due fresh water leaching.

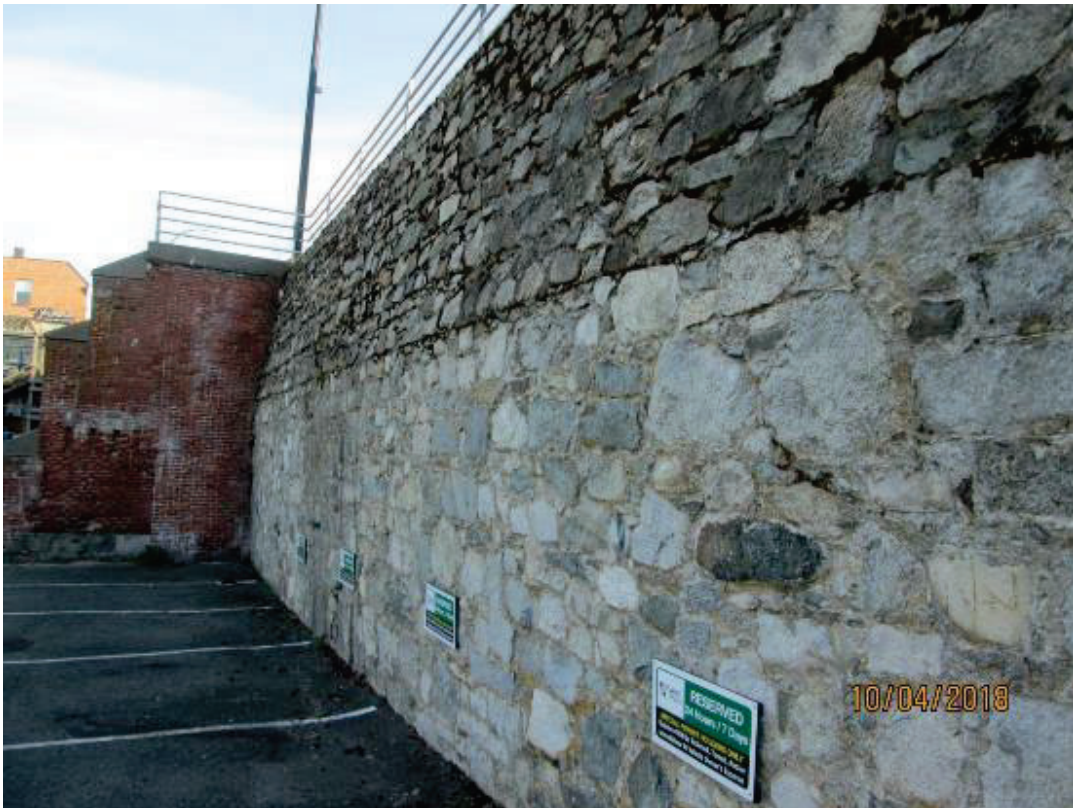
PHOTO 77: General view of the stone retaining wall, showing the upper sloped (battered) section.

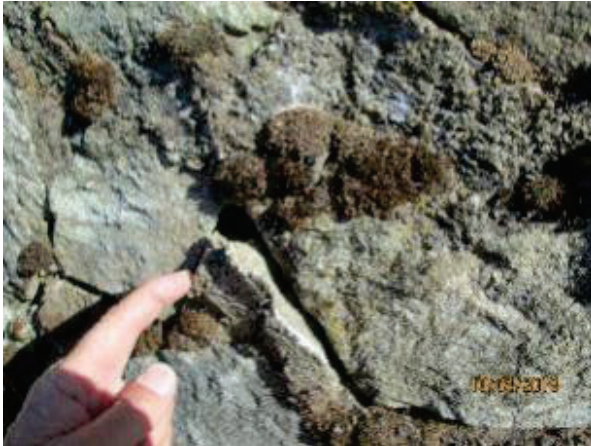
PHOTO 80: Failed mortar joints, cracks vary in width from 10mm to 25mm.

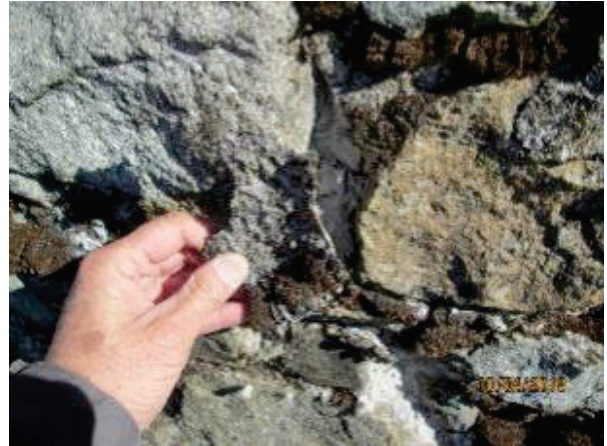
PHOTO 81: Loose stonework. Several of the smaller stone filler pieces where coursing and levelling occurred during construction are now loose or debonded from the wall.

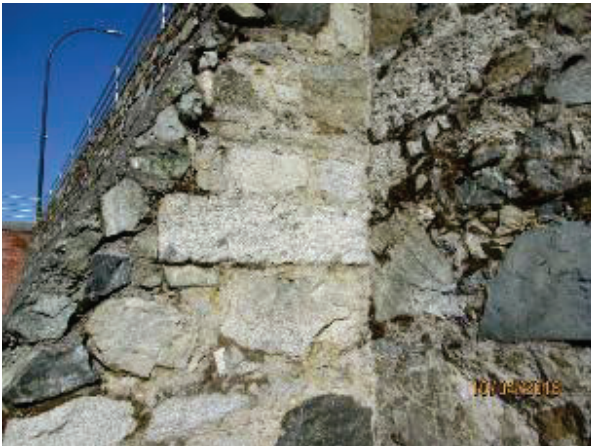
PHOTO 82: Recent repairs to the buttress are evident. Stone has been added to provide a facing guide for the sloped mortar cap.

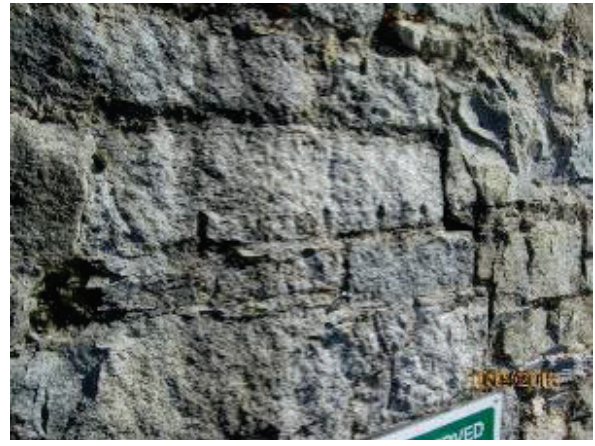
PHOTO 83: several granite blocks were originally shaped using the plug and feather technique.

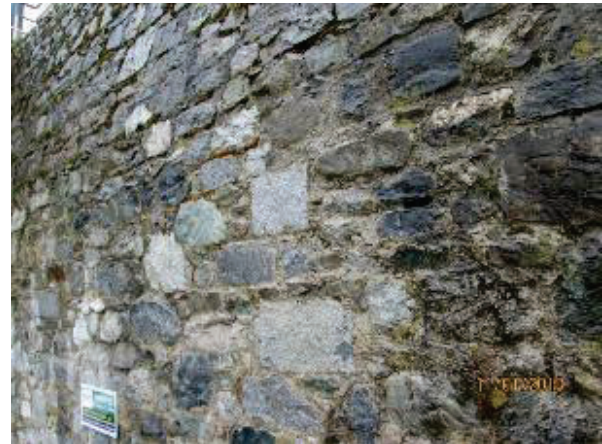
PHOTO 85: A distinct drainage and wetting pattern to the surface of the wall was observed during a recent high rain event.

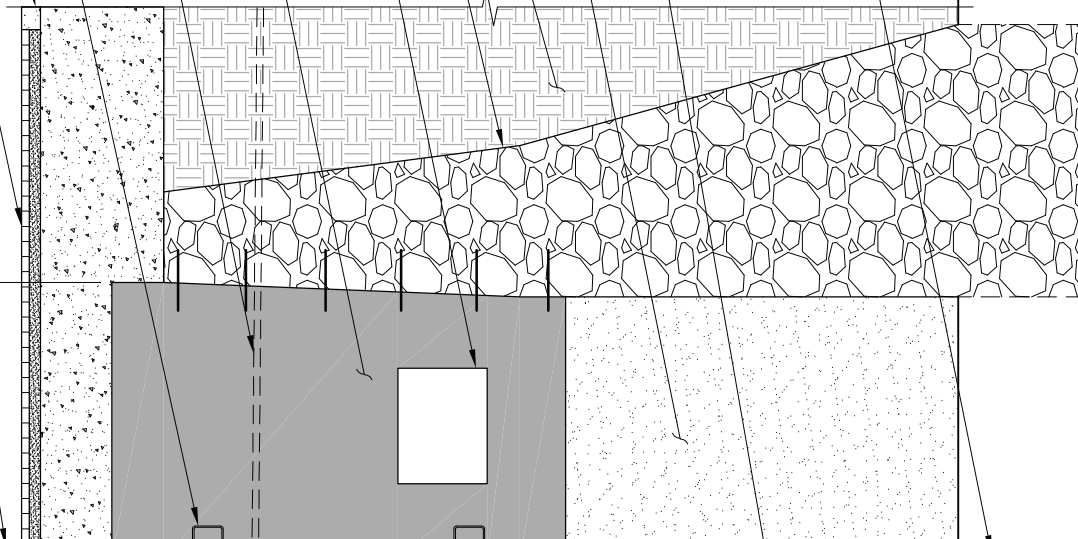
GRANITE SLAB FOUNDATION
