DUCK'S CARRIAGE FACTORY

615-625 JOHNSON STREET, VICTORIA, BC

CONSERVATION PLAN

DONALD LUXTON
AND ASSOCIATES INC

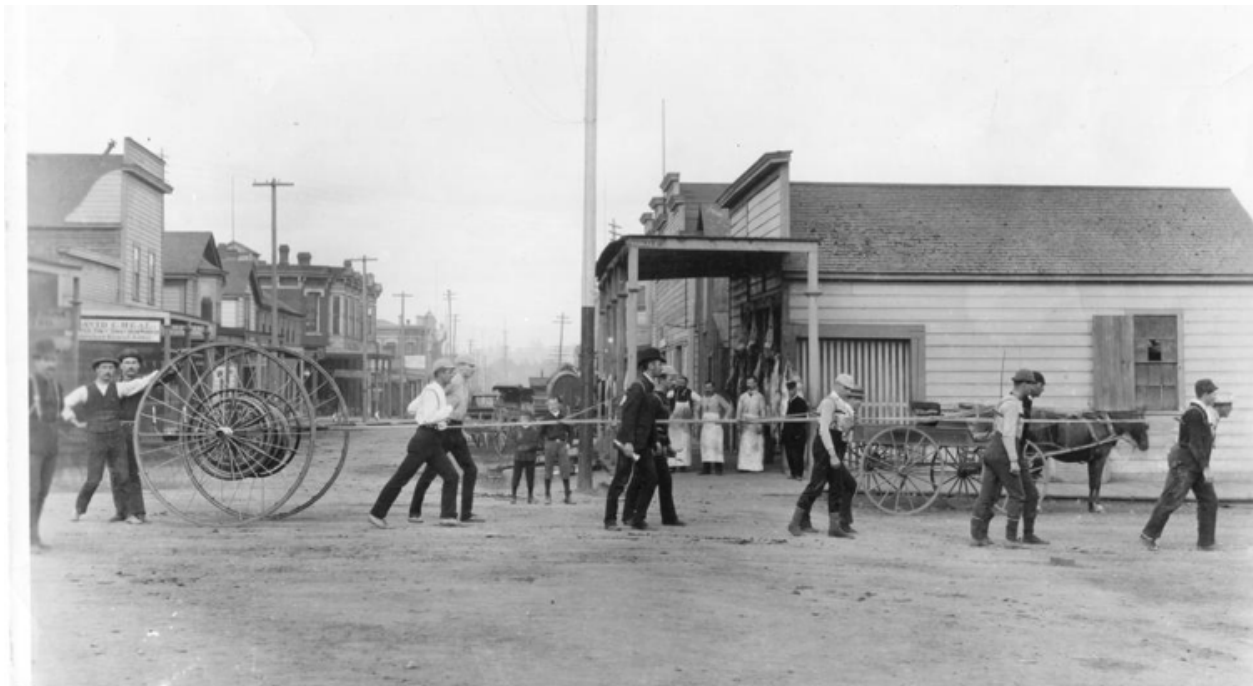
Hose Reel Drill Team preparing for competition at corner of Johnson and Douglas Streets; Victoria Fire Department, circa 1887. First Duck's Carriage Factory, with chimneys and arcade, can be seen centre left. [British Columbia Archives A-04734]

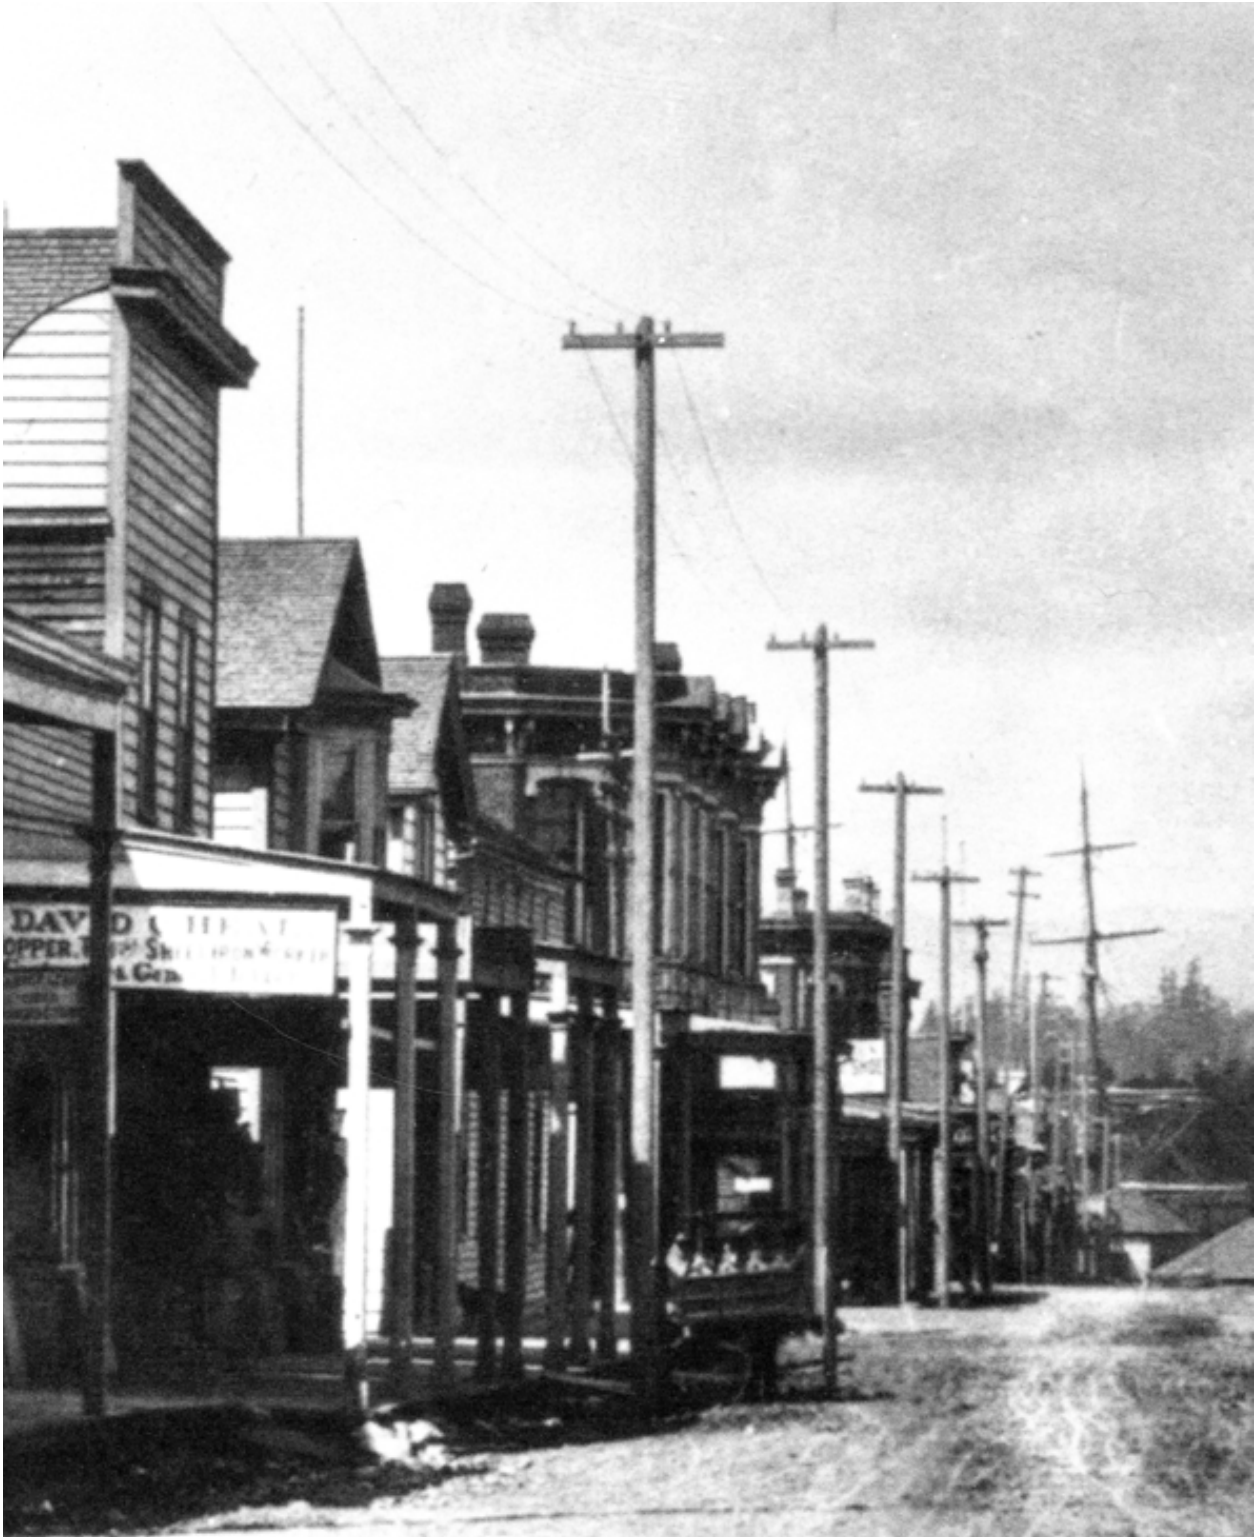
Johnson Street, 1877. First Duck's Carriage Factory, with chimneys and arcade, can be seen at centre; the two westernmost bays can be seen to be different in appearance. [City of Victoria Archives M06538]

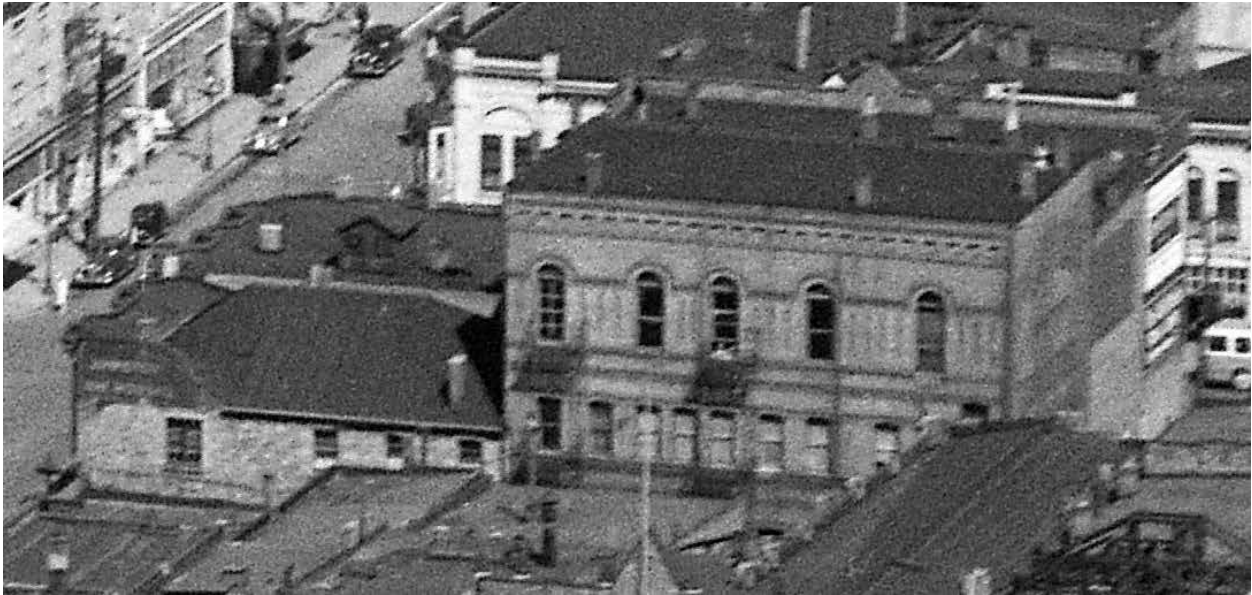
Victoria 1947 BO-47-1455 detail showing alley elevation. Note that the hipped roof of the Carriage Factory is still visible. It was later raised and flattened to match the roofline of the First Duck's Carriage Factory, and the stone wall extended upward in brick.

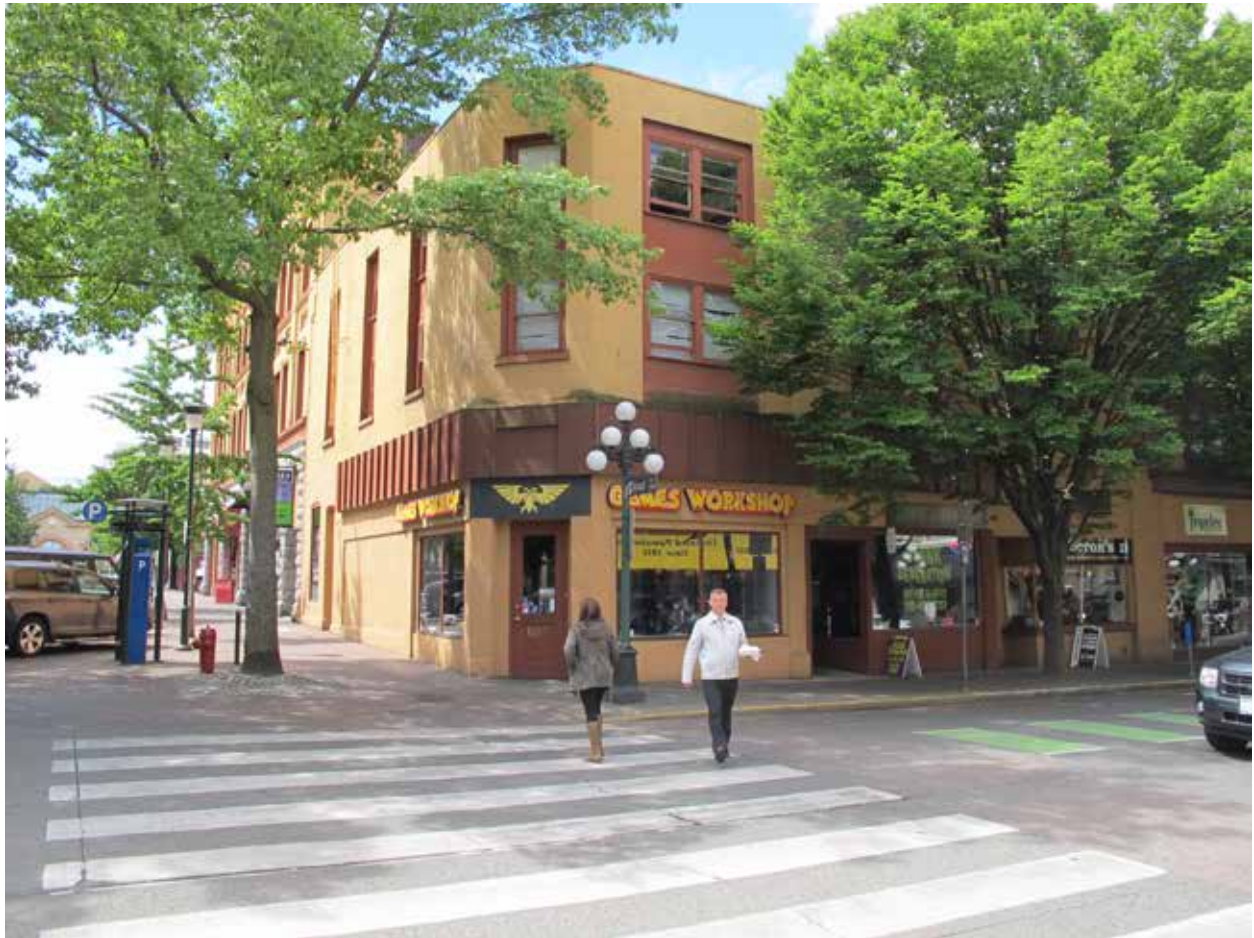
A condition review of the Duck's Carriage Factory was carried out during a site visit in June 2017. The recommendations for the rehabilitation of the structure are based on the site review, material samples and archival documents that provide valuable information about the original appearance of the historic building.

- Preserve the character-defining rubble stone wall.
- Surviving sills and lintels require investigation to determine extent of structural integrity. Repair as required.

- Undertake complete condition survey of condition of all stone surfaces.
- Cleaning, repair and repointing specifications to be reviewed by Heritage Consultant.

- All redundant metal inserts and services mounted on the exterior walls should be removed or reconfigured.
- Overall cleaning of the stone on the exterior rear elevation should be carried out. Do not use any abrasive methods that may damage the surfaces. Use a soft natural bristle brush and mild water rinse. Only approved chemical restoration cleaners may be used. Sandblasting or any other abrasive cleaning method of any kind is not permitted.

- Repoint as necessary by raking out loose mortar material to a uniform depth. Work should only be undertaken by skilled masons. Do not use power tools to cut or grind joints; hand-held grinders may be used for the initial raking of horizontal joints after test samples have been undertaken and only if approved by the Heritage Consultant. Repoint mortar joints with new mortar that matches existing in consistency, composition, strength, colour and pointing profile; note the finely tooled profile of the original mortar joints.

- Following demolition of surrounding structure, the top of the stone wall will require stabilization and flashing. Careful attention should be paid at interface of original and new material. Protect rehabilitated wall from the elements and stabilize wall as required during demolition phase.

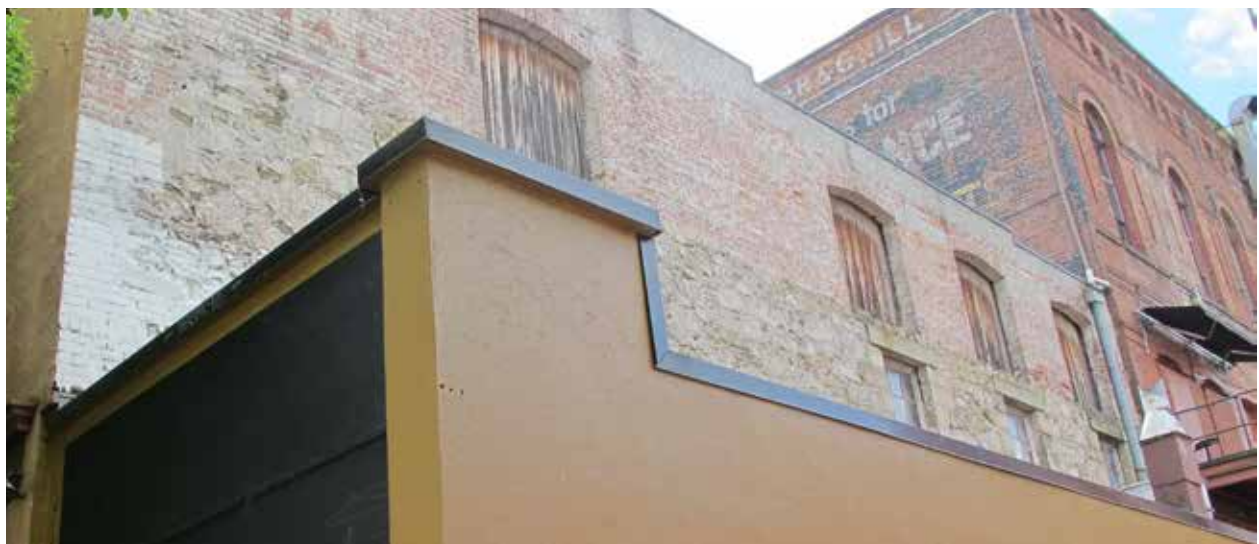
The Duck's Carriage Factory features character-defining double-hung wooden sash windows, which will be replaced with new assemblies. New windows will be installed within existing openings and will reference historic originals.

- Inspect for condition and complete detailed inventory to confirm extent of recommended repair or replacement.
- Install new window assemblies in historically-appropriate configuration within existing openings of rubble wall.
- Review options for energy performance and acoustical upgrades.
- Prime and repaint as required in appropriate colour, based on colour schedule devised by Heritage Consultant.
