**CASE STUDY 1:  
RUINS OF THE WHARF STREET  
HUDSONS BAY COMPANY  
WAREHOUSE: AN INTERPRETATION  
AND CONSERVATION OPPORTUNITY**

## **SITUATION BRIEF # 26**

**Contributors: M. Segger, C. Gower, K. Johnson**

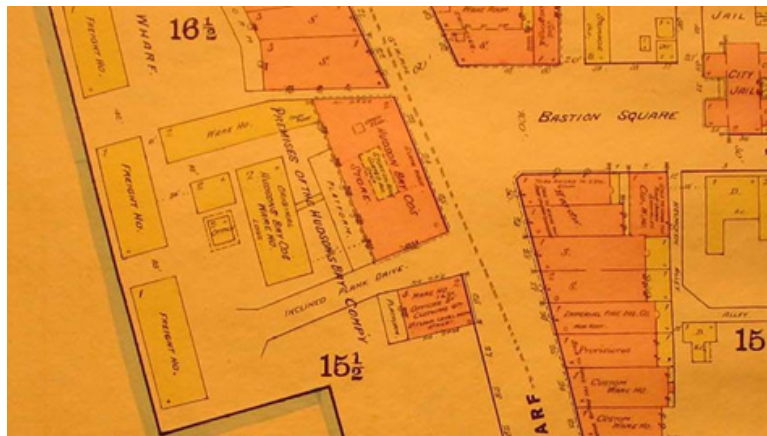
Early Victoria Fire Insurance Map shows footprint of HBC Warehouse.

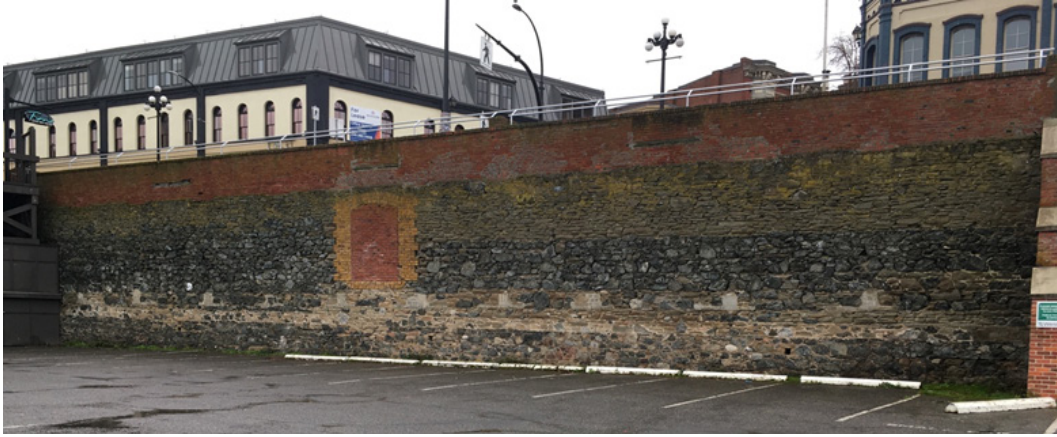
Western retaining wall and first floor interior elevation of the 1858 HBC Warehouse on Wharf Street, Victoria.

The original walls offer a two-hundred-year vantage: looking both back to the 1850's - and possibly ahead to the 2050s - a very rare opportunity in a young North American city. Because remnants of both the east and the north foundation walls remain, one can actually see the outlines of the corners of the building (likely exactly 50 feet long). Furthermore, the surface of the parking lot could be stripped off revealing the original foundation footings, thus the outline of this massive structure.

Within the original stone and brick coursing is the original mortar grout still as hard and solid as 150 years ago. These walls are massive and solidly assembled masonry an embodied metaphor of endurance.

Above, just below street-level one can see the bases of the three original doorways to Wharf Street - and a remainder of the brick original second-floor level wall construction, acting now as a guard wall for the sidewalk - all part of a mostly-lost building's continuing ghost frontage beside Wharf Street.

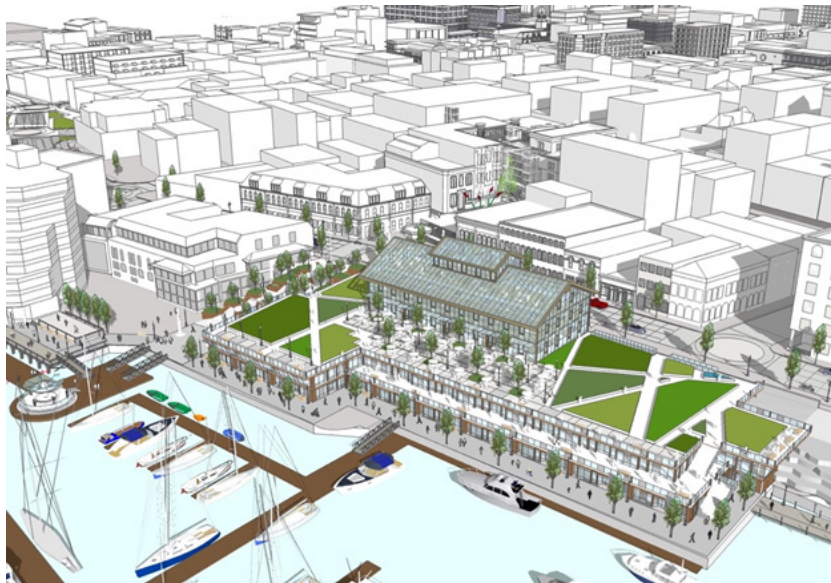
In the study, a glazed version of the warehouse rises from a two-storey podium fronting the harbour. Stairways and light-wells open onto the historic walls - with public views possible both from above - and as one might descend to lower building floors. (Design and image Chris Gower AIBC copyright 2021)

Local architect Chris Gower has suggested we could reimagine the warehouse scale and form but expressed in contemporary materials. His resulting design proposal could be adapted for use as a museum or festival centre. At the very least the surviving masonry wall, long-neglected, and it seems all but forgotten, deserves an interpretive panel explaining its critical but
